NTSB ISSUES UPDATE ON INVESTIGATION INTO FATAL PIPELINE RUPTURE IN SAN BRUNO, CALIFORNIA

This is an update on the continuing investigation of the natural gas pipeline rupture and explosion that killed eight people in San Bruno, Calif., on September 9, 2010.

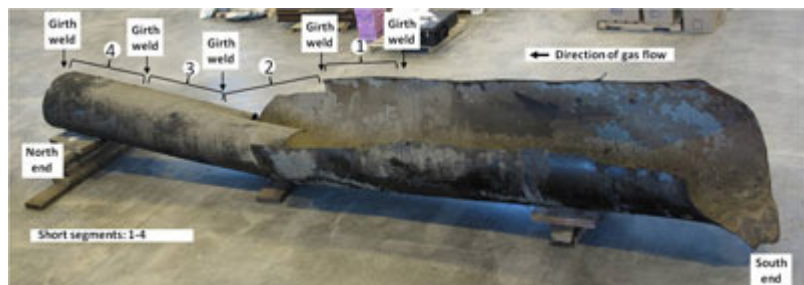
28-foot-long ruptured section of pipeline at laboratory facilities at the NTSB Training Center, Ashburn, VA

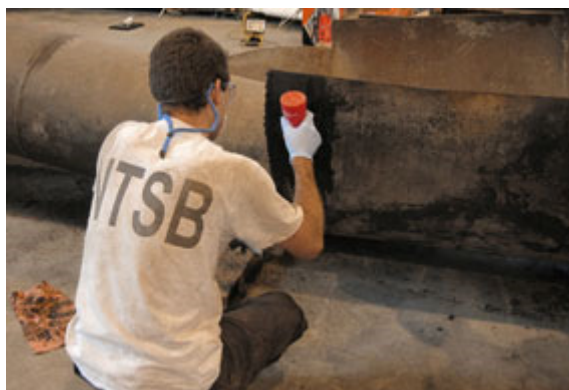
NTSB investigator examining fracture surfaces

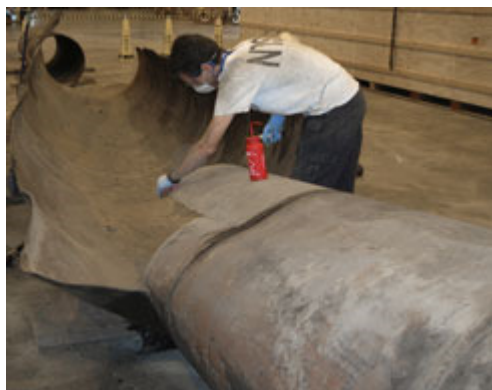
View of ruptured section of pipeline with investigator cleaning a fracture surface

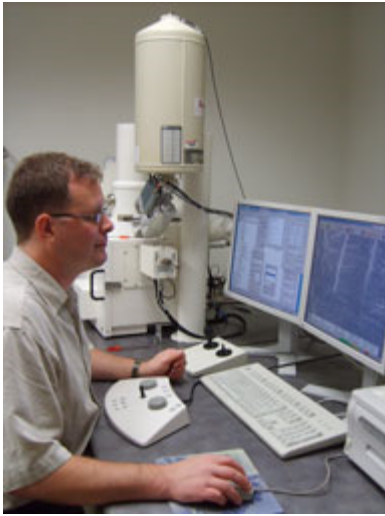
NTSB investigator using a scanning electron microscope to examine a pipeline fracture surface
